GLENN LUKOS ASSOCIATES

December 18, 2007

SUBJECT: CCC Jurisdictional Delineation for the Foothill Transportation Corridor - South,
Orange County, California.

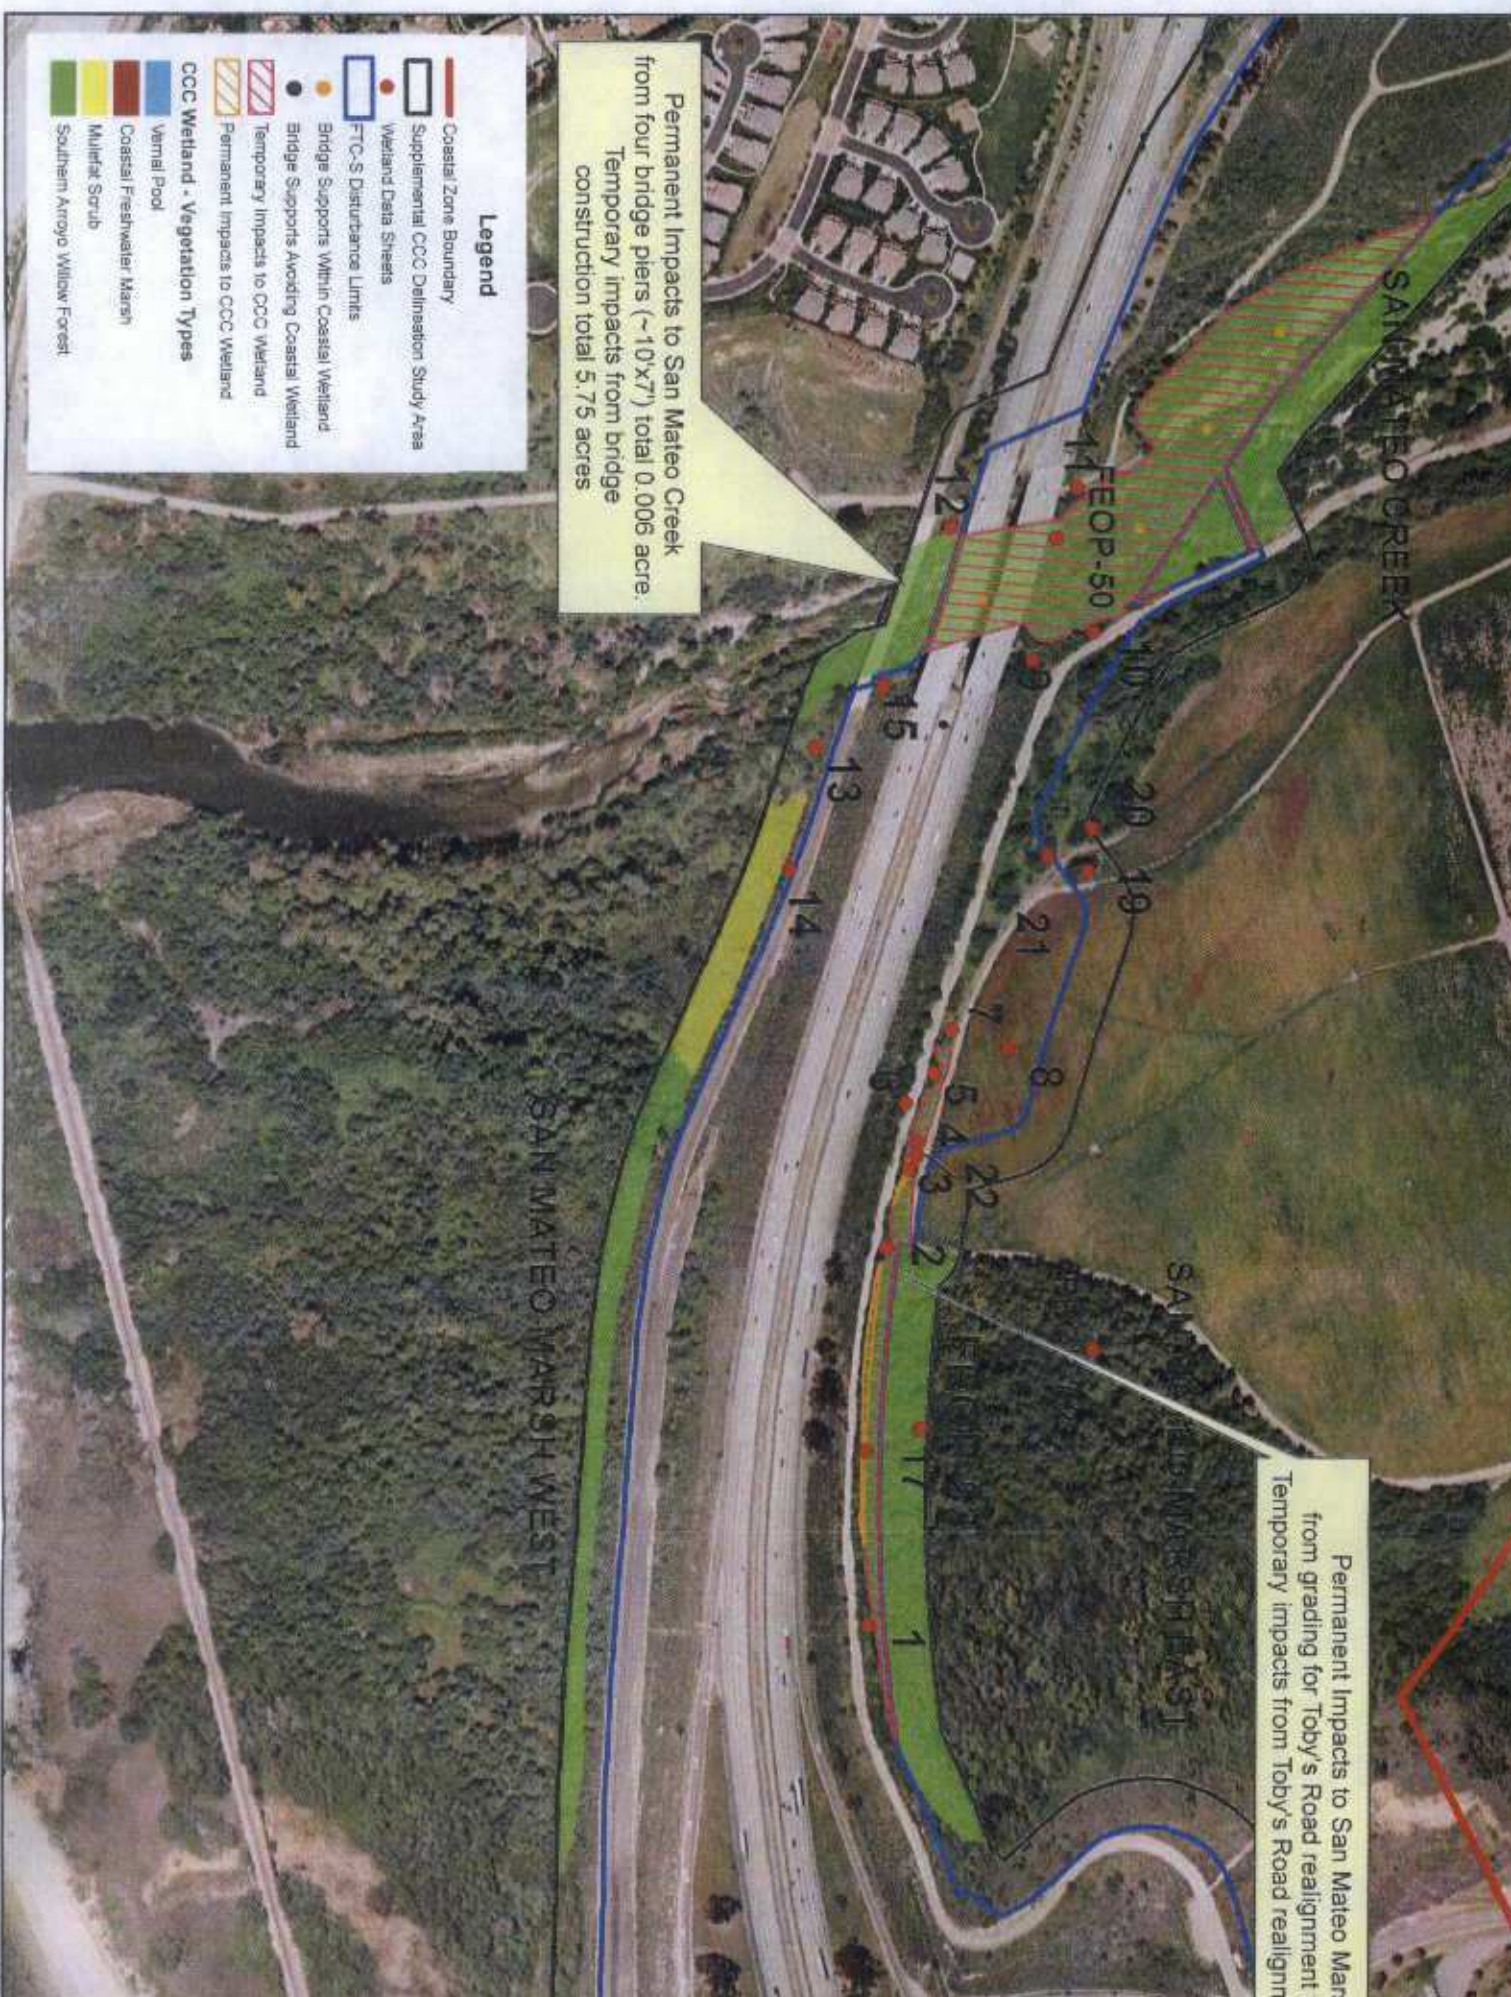
Permanent Impacts to San Mateo Creek
from four bridge piers (~10'x7') total 0.006 acre.
Temporary impacts from bridge
construction total 5.75 acres

Permanent Impacts to San Mateo Marsh
from grading for Toby's Road realignment
Temporary impacts from Toby's Road realignment

Permanent Impacts to San Mateo Marsh
from grading for Toby's Road realignment
Temporary impacts from Toby's Road realign

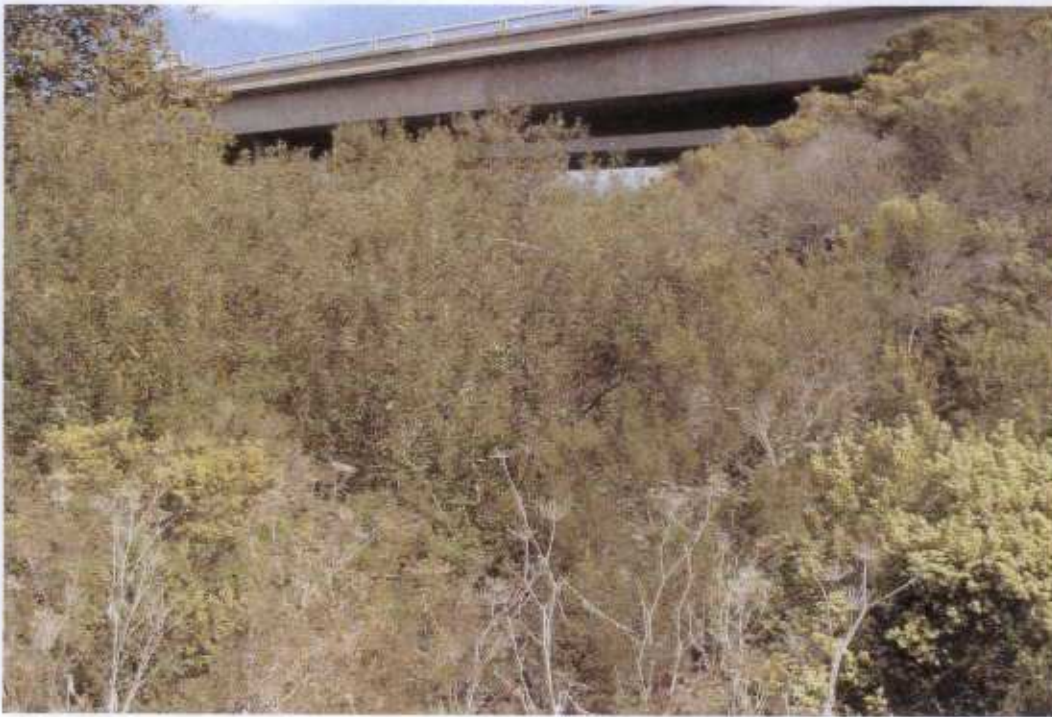
PHOTOGRAPH 1: Southeast Edge of San Mateo Creek looking northeast from footbridge. Note the distinct change in vegetation: Willows on left edge of photo are rooted at base of abutment.

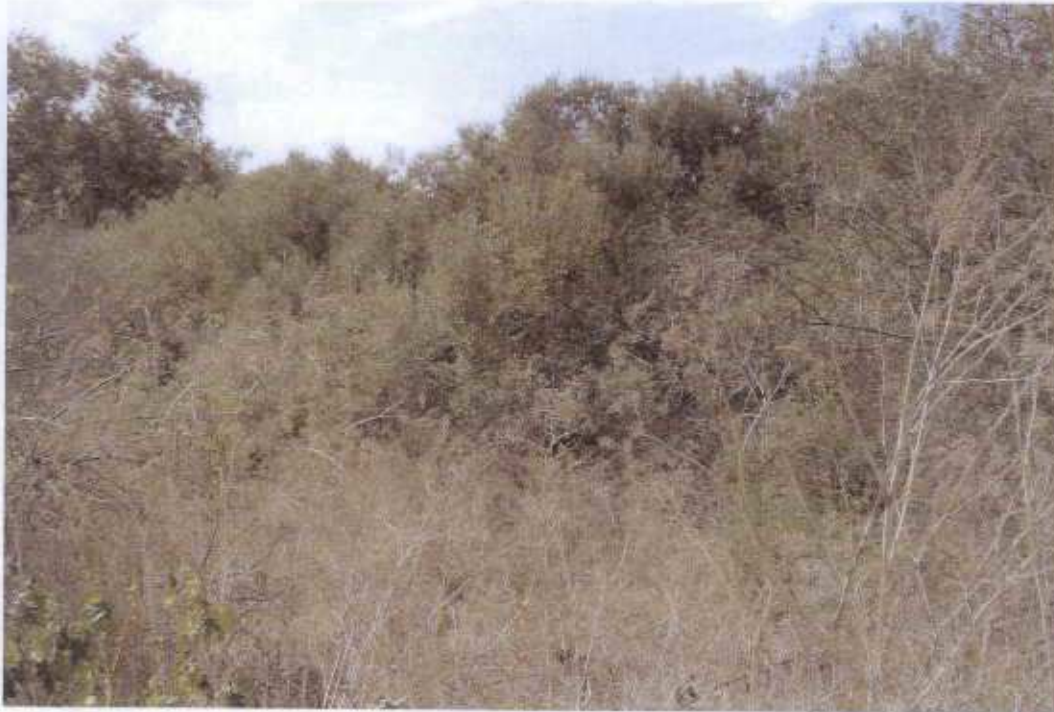
PHOTOGRAPH 2: Southeast Edge of San Mateo Creek looking southwest from footbridge. Note the distinct change in vegetation: Willows in background are rooted at base of bank.

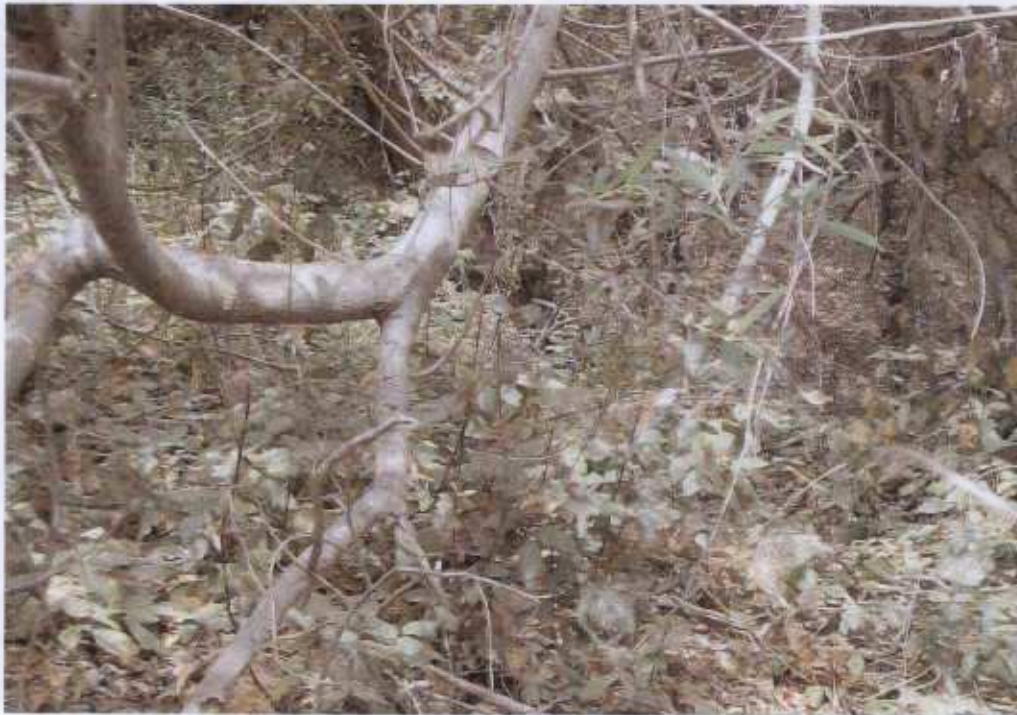
PHOTOGRAPH 3: Margin of San Mateo Marsh at Toby's road. Road is elevated several feet above marsh. Tree layer at margin dominated by arroyo willow, understory dominated by poison oak.

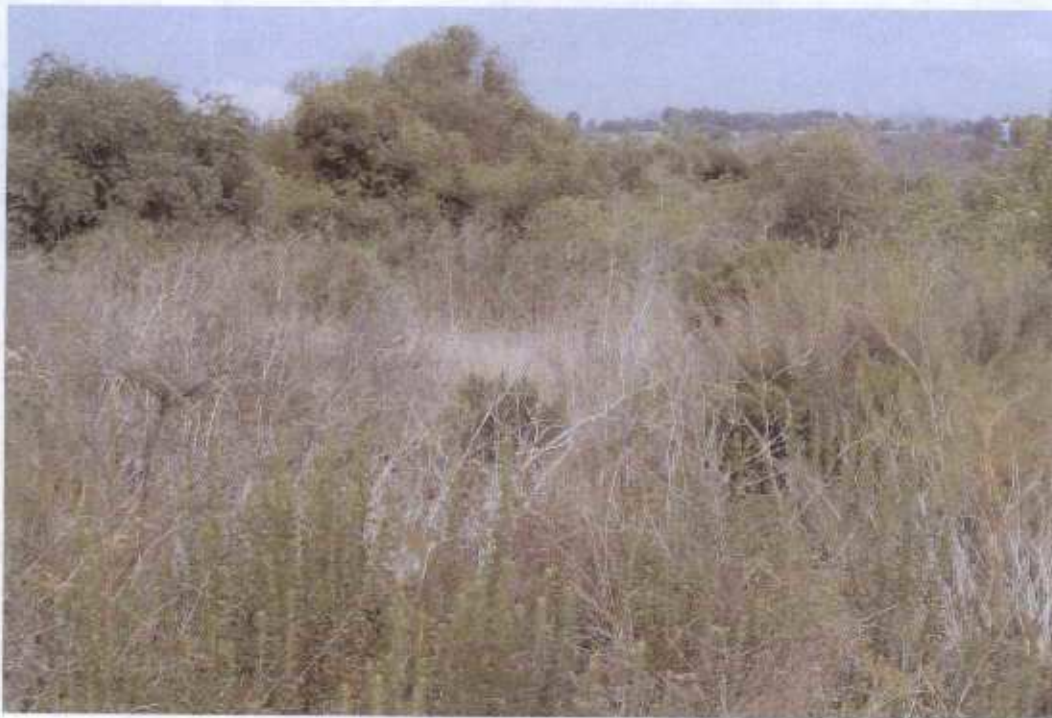
PHOTOGRAPH 4: Typical Mexican elderberry woodland

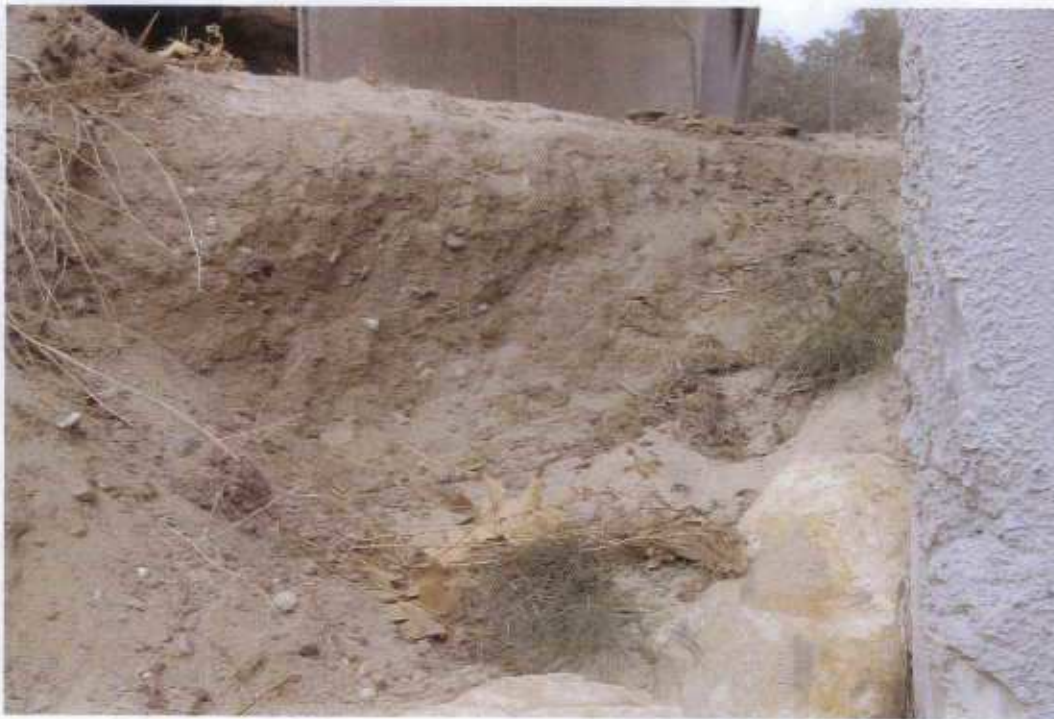
PHOTOGRAPH 5: Soils at San Onofre/I-5 Bridge. No wetland hydrology or hydric soils were detected.

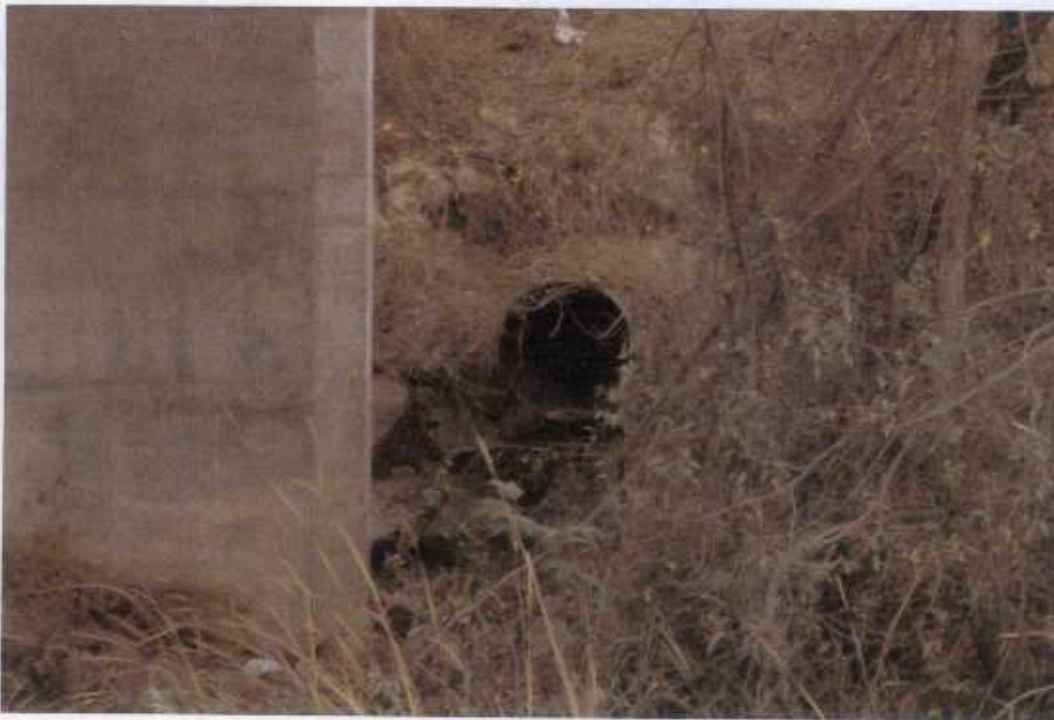
PHOTOGRAPH 6: Additionally, note the distinct change in vegetation at the toe of the slope.
